3-YEAR ASBESTOS INSPECTION REPORT

JOHN G. WHITTIER ELEMENTARY SCHOOL SCRANTON, PA (NATIVITY - ANNEX BUILDING)

SCRANTON SCHOOL DISTRICT
425 North Washington Avenue
Scranton, Pa. 18505

PROJECT: #SSD.19_751

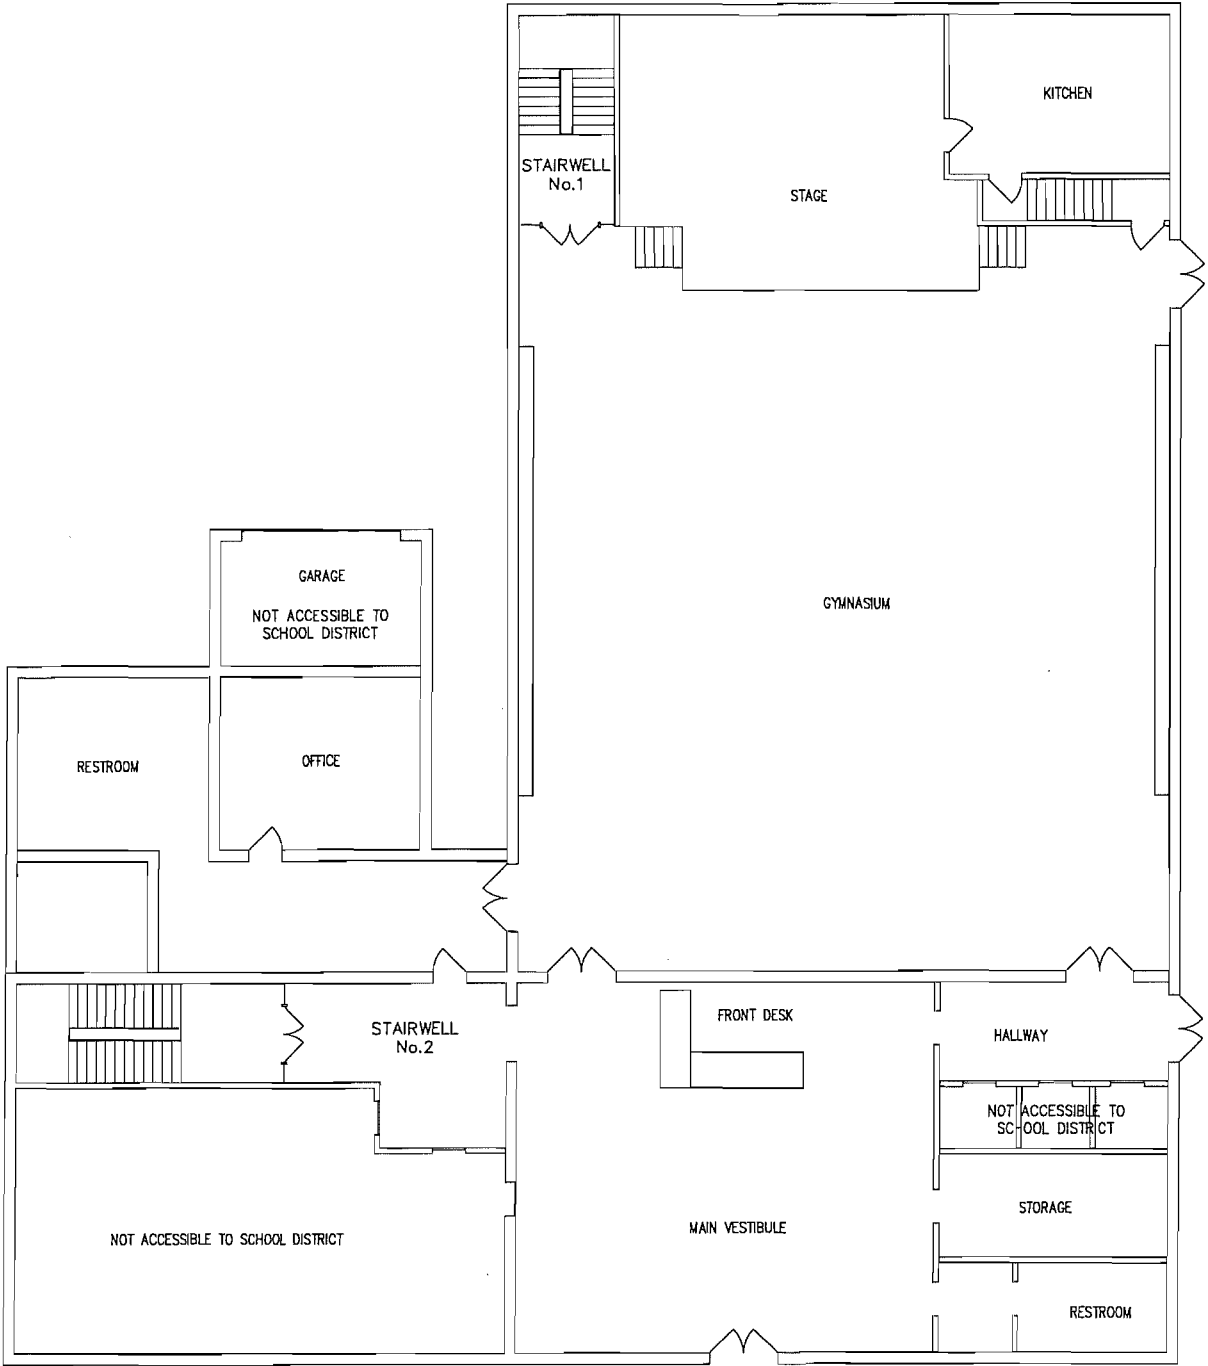
1ST FLOOR PLAN
NOT TO SCALE

KEY - SURFACING ACM
ASSUMED ASBESTOS CONTAINING
SURFACING MATERIALS:
1. EXTERIOR COATING ON SINKS

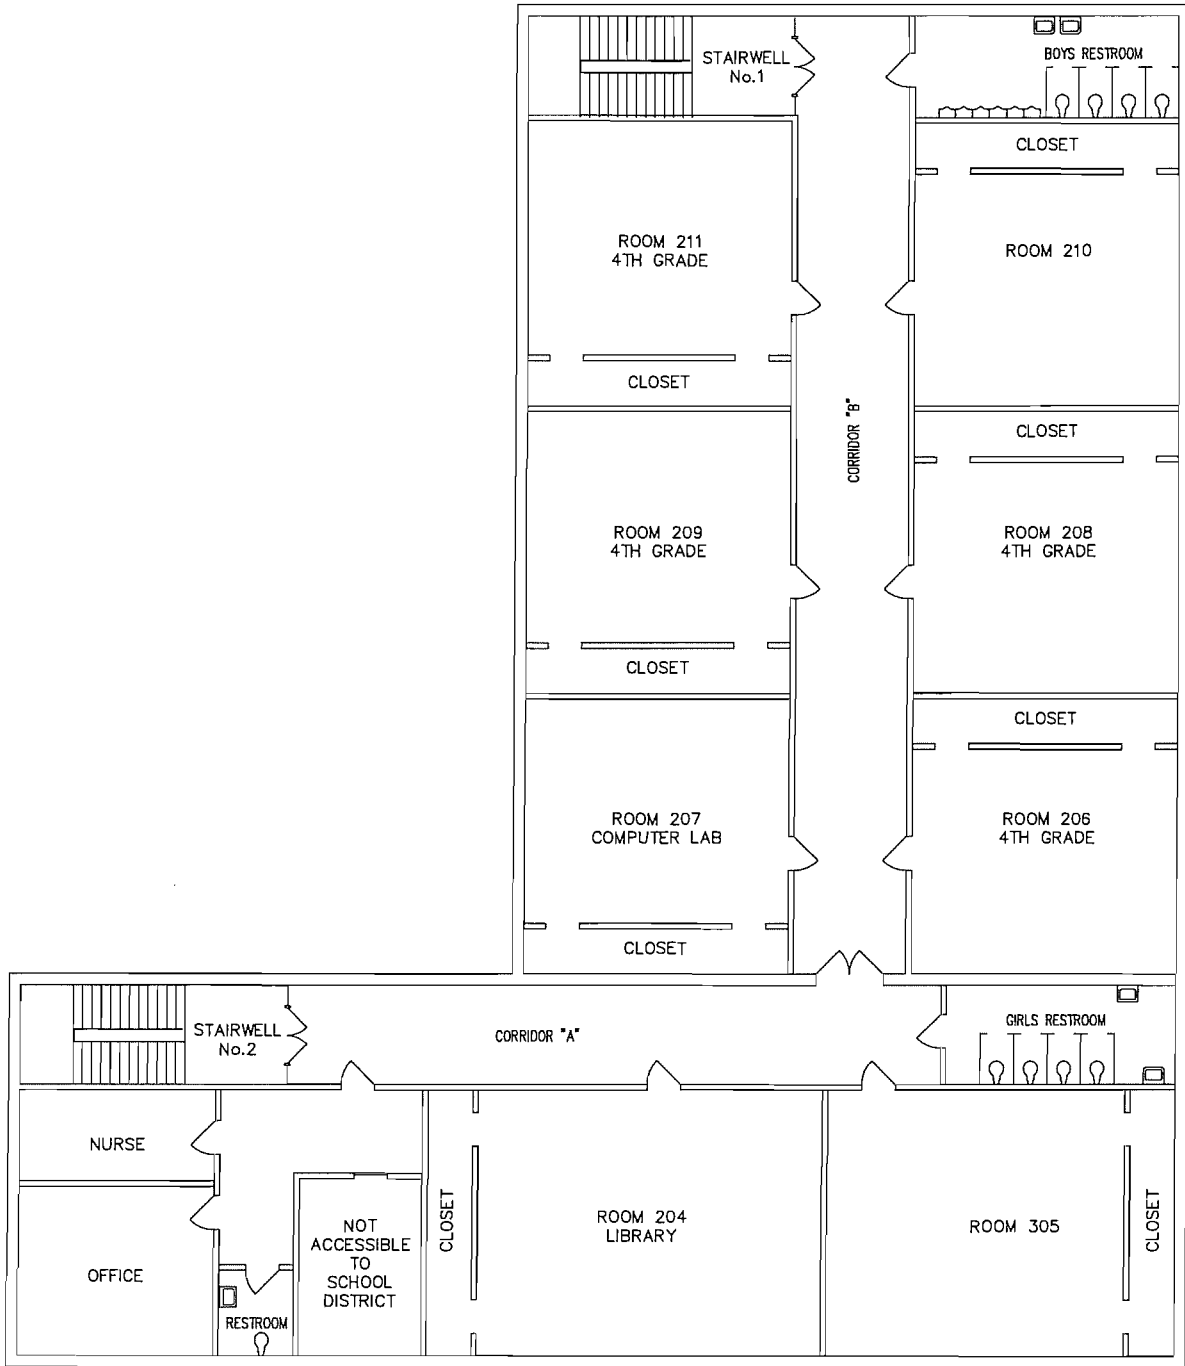
2ND FLOOR PLAN
NOT TO SCALE

KEY - SURFACING ACM
ASSUMED ASBESTOS CONTAINING
SURFACING MATERIALS:
1. EXTERIOR COATING ON SINKS

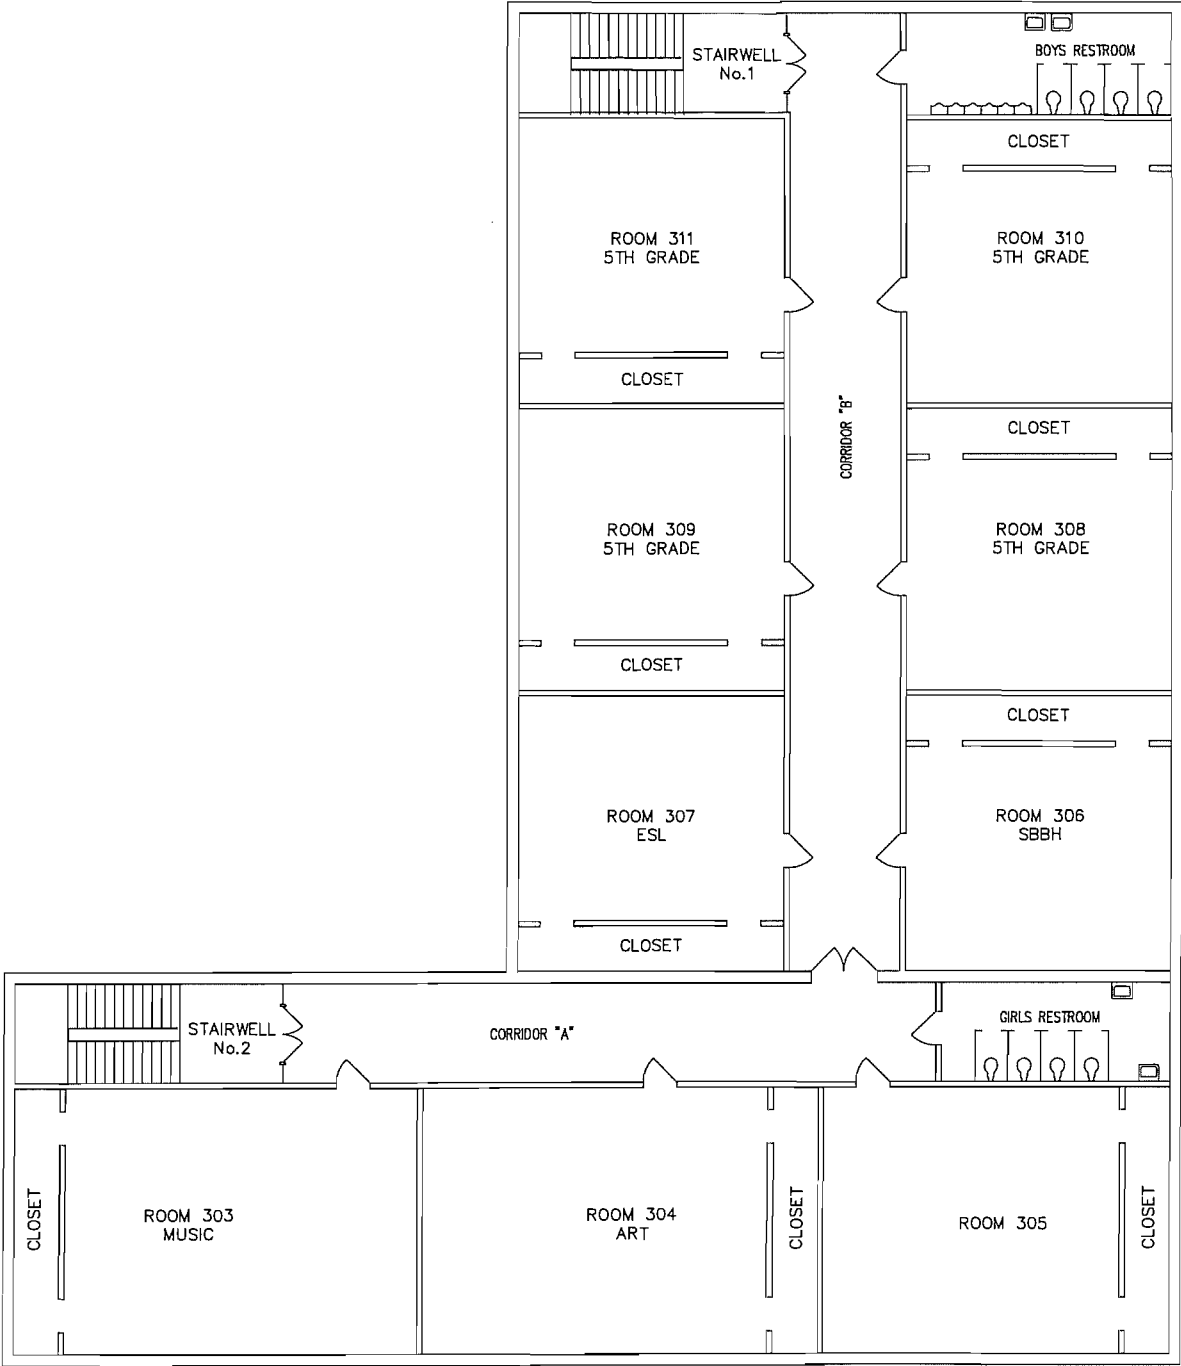
3RD FLOOR PLAN
NOT TO SCALE

KEY - SURFACING ACM
ASSUMED ASBESTOS CONTAINING
SURFACING MATERIALS:
1. EXTERIOR COATING ON SINKS

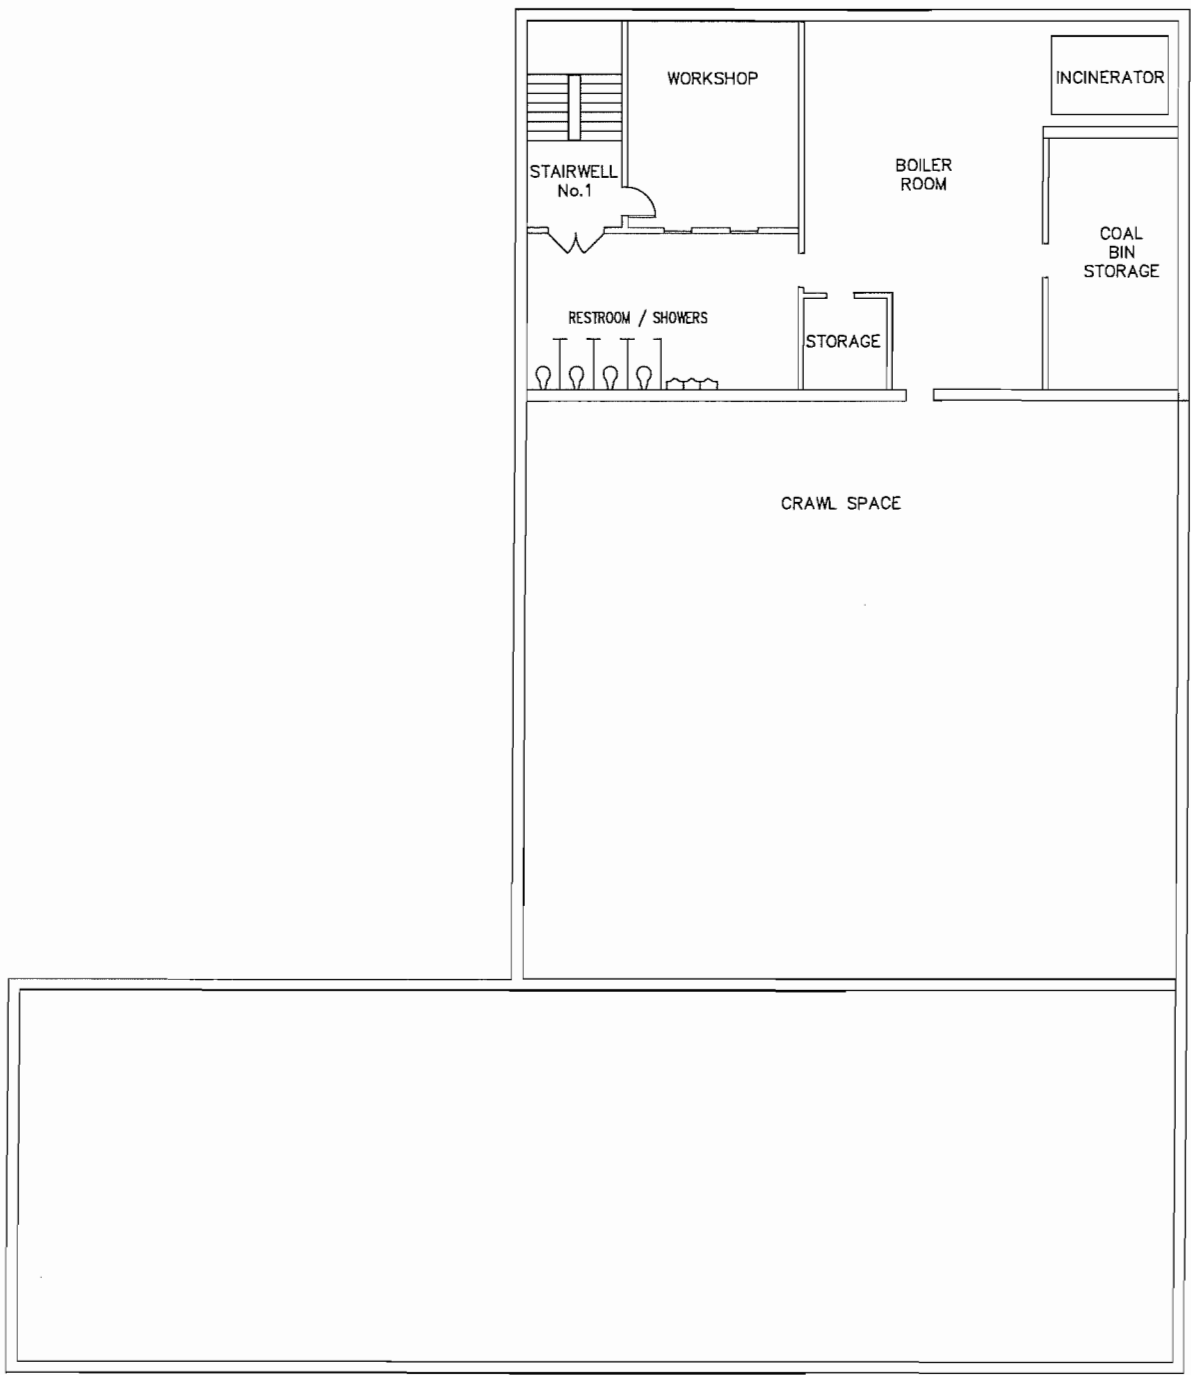
BASEMENT PLAN
NOT TO SCALE

ASSUMED ASBESTOS CONTAINING MISCELLANEOUS MATERIALS:

1. OLD ELECTRICAL WIRING

2. MARBLE MASTIC

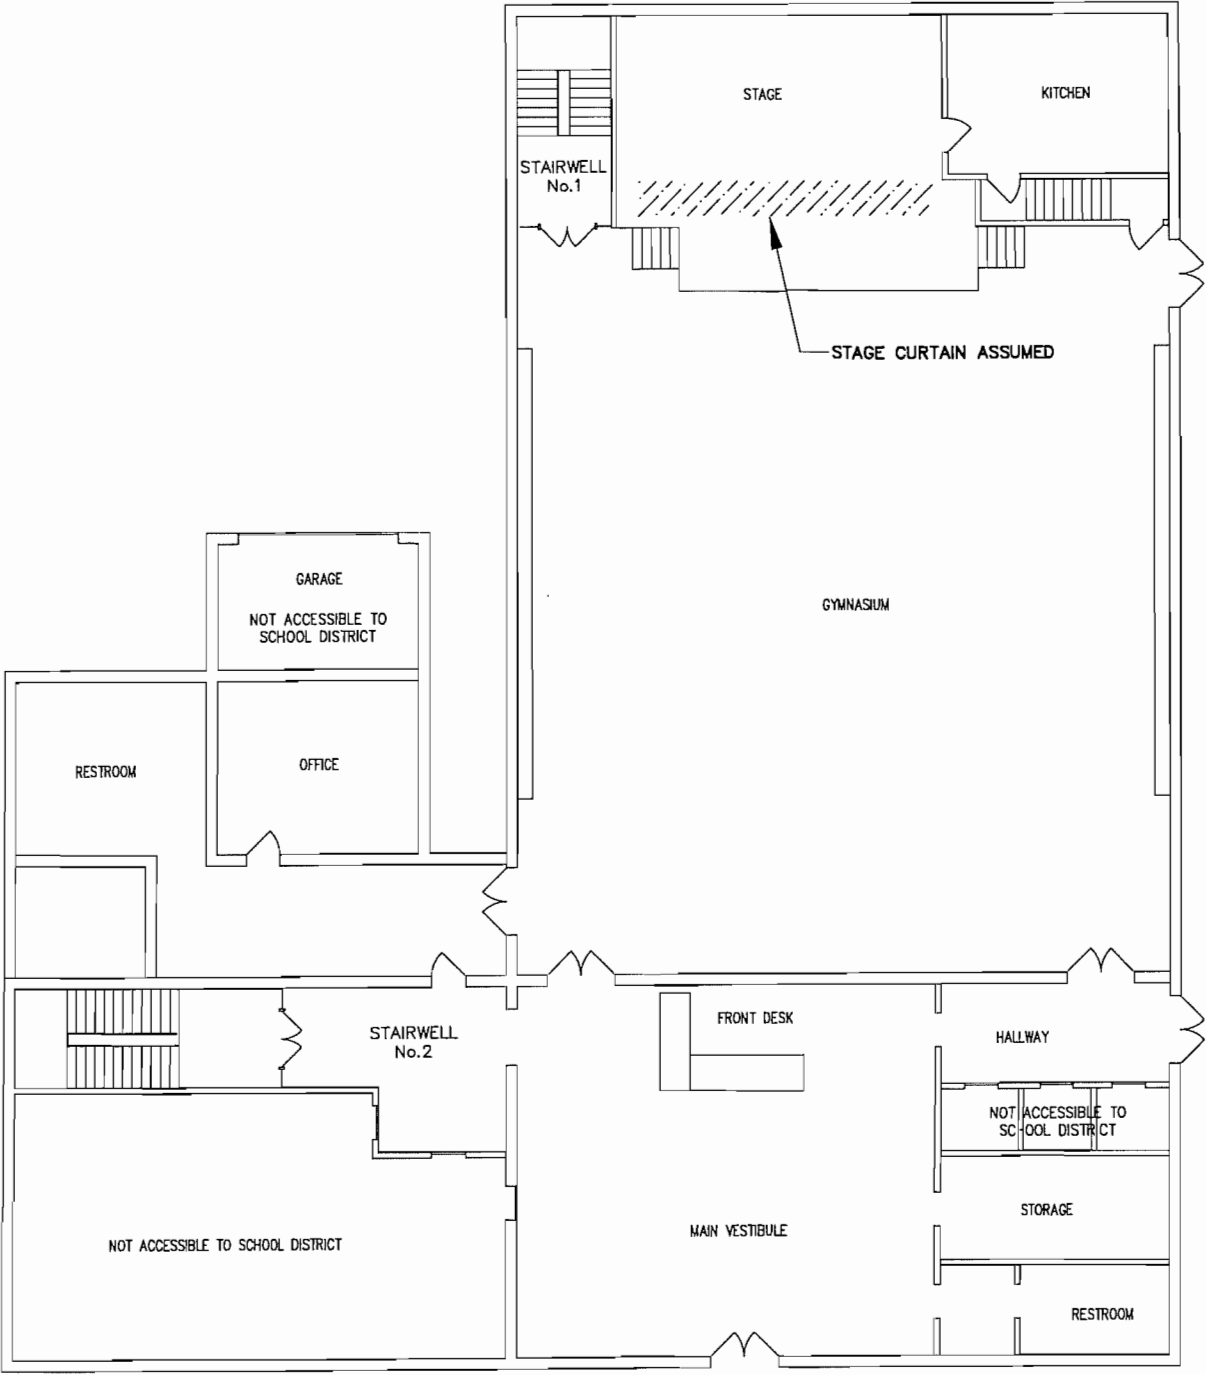
1ST FLOOR PLAN
NOT TO SCALE

STAGE CURTAIN (ASSUMED)

CONFIRMED ASBESTOS CONTAINING MISCELLANEOUS MATERIALS:

1. INTERIOR WINDOW CAULKING

ASSUMED ASBESTOS CONTAINING MISCELLANEOUS MATERIALS:

1. CHALKBOARD MASTIC

2. MARBLE MASTIC

3. DUCTWORK FLEX CONNECTIONS

4. OLD ELECTRICAL WIRING

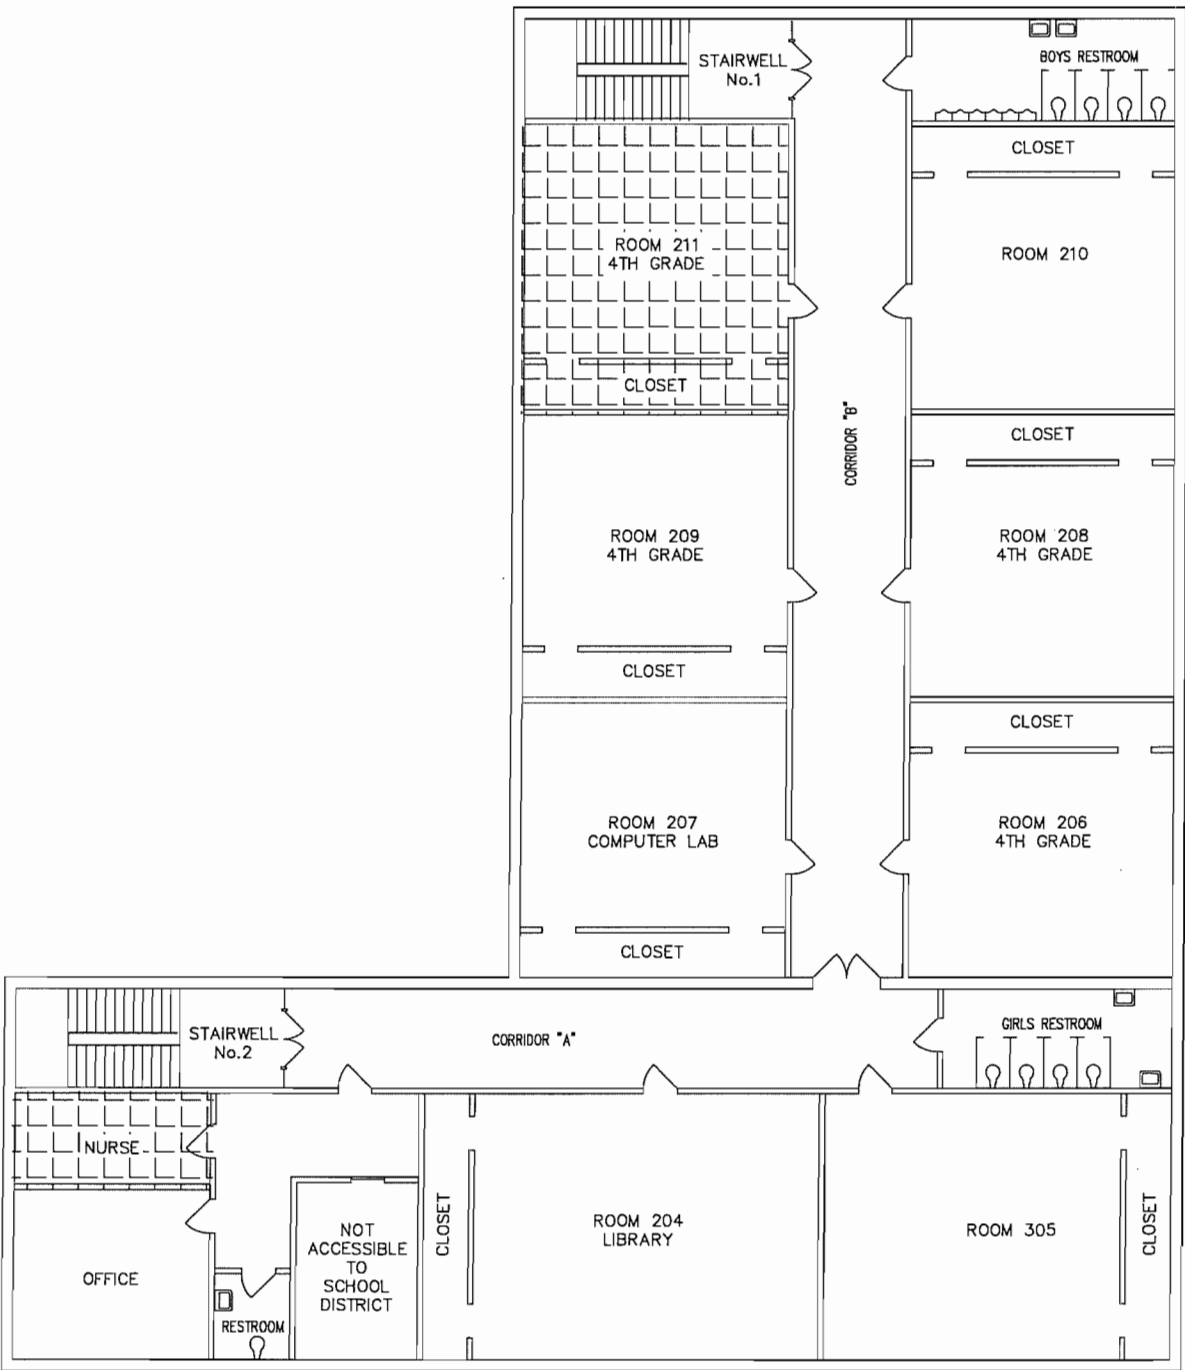
2ND FLOOR PLAN
NOT TO SCALE

12"x12" FLOOR TILE & MASTIC

CONFIRMED ASBESTOS CONTAINING MISCELLANEOUS MATERIALS:

1. INTERIOR WINDOW CAULKING

ASSUMED ASBESTOS CONTAINING MISCELLANEOUS MATERIALS:

1. CHALKBOARD MASTIC
2. MARBLE MASTIC
3. DUCTWORK FLEX CONNECTIONS
4. OLD ELECTRICAL WIRING

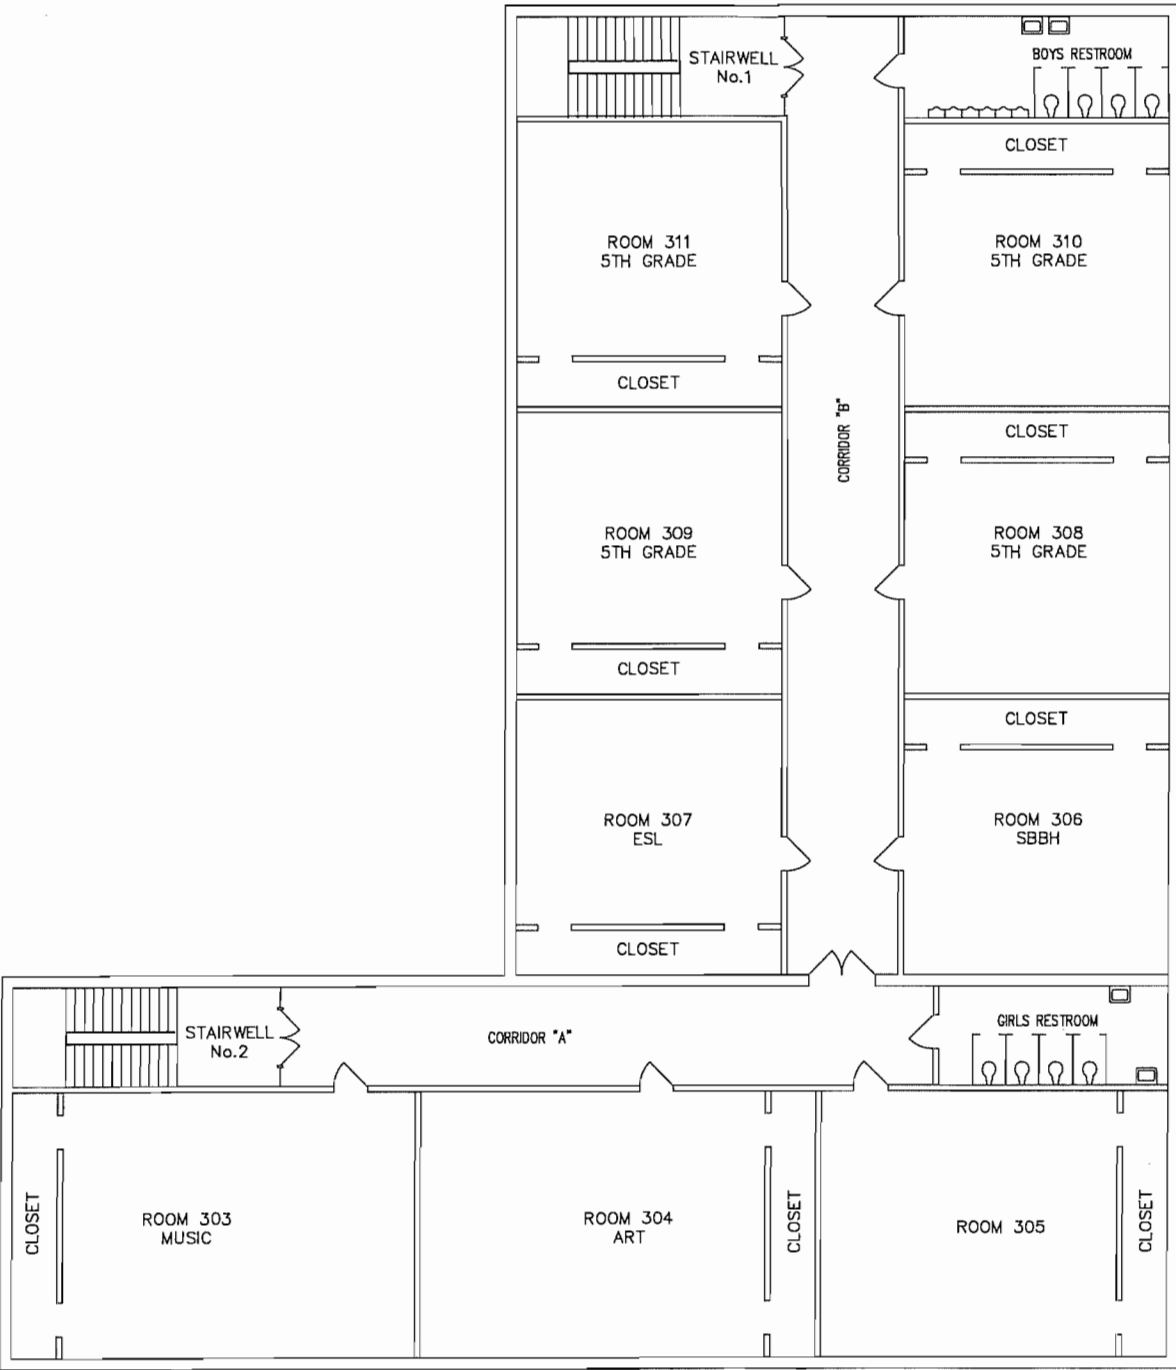
3RD FLOOR PLAN
NOT TO SCALE

CONFIRMED ASBESTOS CONTAINING MISCELLANEOUS MATERIALS:

1. INTERIOR WINDOW CAULKING

ASSUMED ASBESTOS CONTAINING MISCELLANEOUS MATERIALS:

1. CHALKBOARD MASTIC
2. MARBLE MASTIC
3. DUCTWORK FLEX CONNECTIONS
4. OLD ELECTRICAL WIRING
